A Detonation Scenario

by Les Waters and Kimble D. McCutcheon

Excerpted from *Torque Meter*, the Quarterly Journal of
The Aircraft Engine Historical Society, Inc.
1019 Old Monrovia RD NW STE 201
Huntsville, AL 35806 www.enginehistory.org

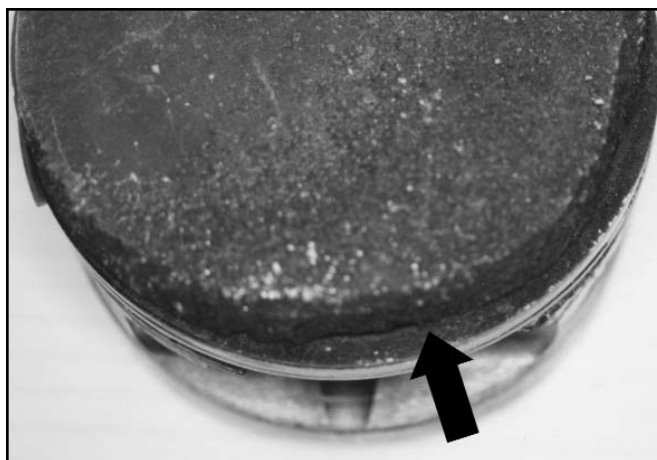
An IO-520 Series Piston that has Suffered Severe Detonation Damage. Note that piston crown erosion has progressed to the point that a path has formed around the steel top-ring insert (arrow) that is cast into the piston. The most visible damage appears in the sector between the exhaust valve, which would be near the arrow, and the lower spark plug, which would be on the right. (Les Waters)

Detonation usually occurs near an exhaust valve, which is already operating at a red heat and contributes to end gas heating through radiation. The explosion of the end gas creates dramatic local heating. More importantly, each detonation event creates a shock wave that bounces around the cylinder, scrubbing away the boundary layer gasses from cylinder head, valves and piston crown, promoting further heating and delivering considerable mechanical distress. The extra heating rapidly overwhelms the piston's ability to dissipate heat, and the piston crown starts to melt and erode in the vicinity of the exhaust valve. This erosion begins at a poorly-cooled region of the crown edge near the cylinder wall. The metal shed from the piston crown gets everywhere; into the exhaust port, on the cylinder head – it will probably foul a spark plug.

Once the piston top ring land becomes exposed, it gets the full effect of both the flame licking into the crevice and the repeated hammer blows of the detonation waves. The crown circumference is rapidly damaged. The destruction is further accelerated as metal from the piston erodes away from the top ring. In most engines, around 30% of the heat from the piston crown is dissipated to the cylinder wall through the top ring. When this heat-flow path is compromised, it leads to even higher piston temperatures and more severe detonation.

Could this incident have been prevented? This specific scenario is one that could happen between even very thorough 100-hour inspections. Modern engine monitors that measure temperatures in each cylinder could detect and announce the rapidly rising cylinder head temperature that heralds the onset of detonation. A total engine failure could have been averted by throttling back and nursing the sick engine to a maintenance facility. More frequent inspections, ones made by the pilot with the aid of a small flashlight, may have detected baffle damage and

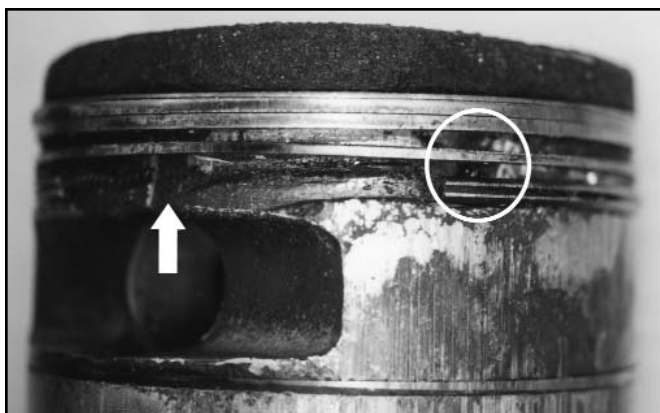
Now the erosion makes its way down the side of the piston and into an oil drain hole under the oil scraper ring. Though not as hot as at the piston crown, the flames are still hot enough to

Once the top ring land is compromised, flames make their way down the side of the piston, causing further erosion (arrow) and eventually finding their way into an oil ring drain hole (circle). Liberated metal particles find their way throughout the engine, leading to the scratching on the piston skirt evident in this view of the piston. (Les Waters)

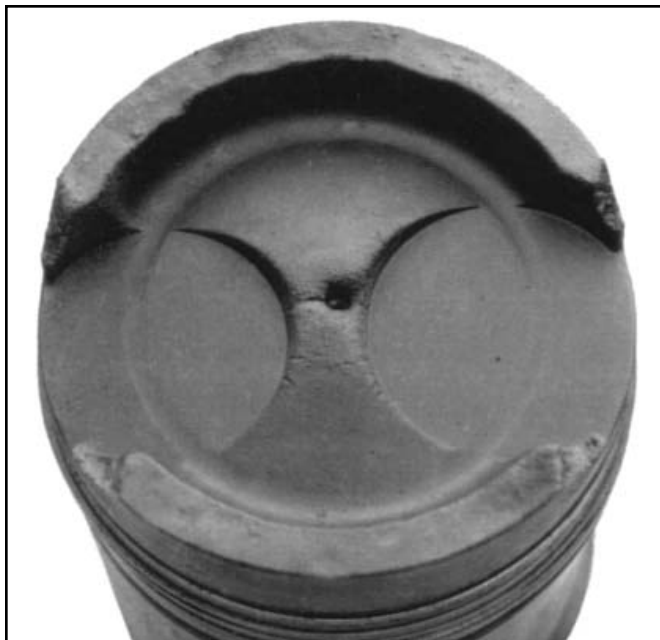
A leaking gas inlet valve can remain alight through the exhaust and intake strokes and provide a “torch” to the air/fuel mixture during the compression stroke, resulting in pre-ignition. When this happens on one cylinder, it is usual that high pressures on the compression stroke result in negative work, reducing engine speed. The governor detects speed reduction and compensates by increasing the fuel supply. This runaway condition results in rapid heating of the cylinder heads and pistons. A rate of temperature increase of 20°F per second has been observed at the cylinder head combustion face. It is seldom possible to shut the engine down before permanent damage is done.

A 10" dual-fuel piston from an engine used to power large electric generators. The piston has been subjected to pre-ignition. Note that, unlike the detonation example, the thermal damage is evenly spread over the piston crown. The piston is made of nodular cast iron, which melts at more than 2,000°F. It must have been subjected to an enormous heat load! The small depression at the center accommodates an eye-bolt used to remove the piston for service. (Les Waters)
